**ENVIRONMENTAL IMPACT
RESEARCH PROGRAM**

TECHNICAL REPORT EL-86-10

BEAVER POND MANAGEMENT

Section 5.5.2, US ARMY CORPS OF ENGINEERS
WILDLIFE RESOURCES MANAGEMENT MANUAL

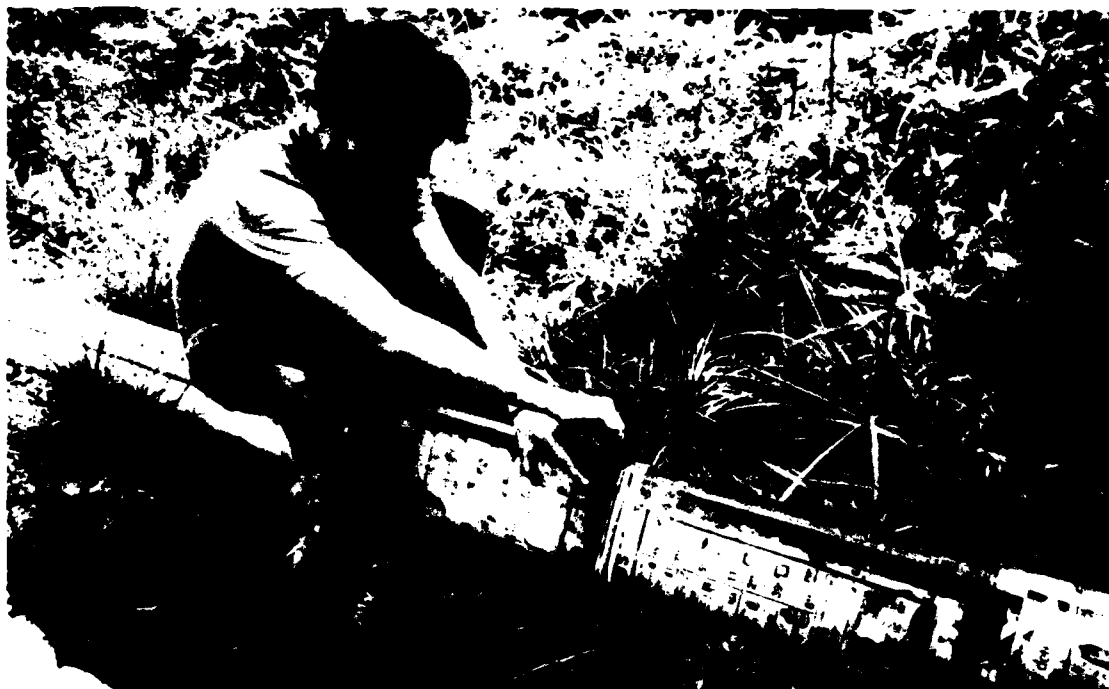
Figure 2. Covering a perforated plastic 3-pipe drain with aluminum newsprint sheets

nearby, one could build and use a 3-pipe drain constructed of perforated plastic pipe and newsprint aluminum. The plastic pipe drain can be covered with aluminum newsprint sheets (Fig. 2) or left uncovered (Fig. 3); local experimentation with the design of this drain is recommended to determine the best option for a particular situation.

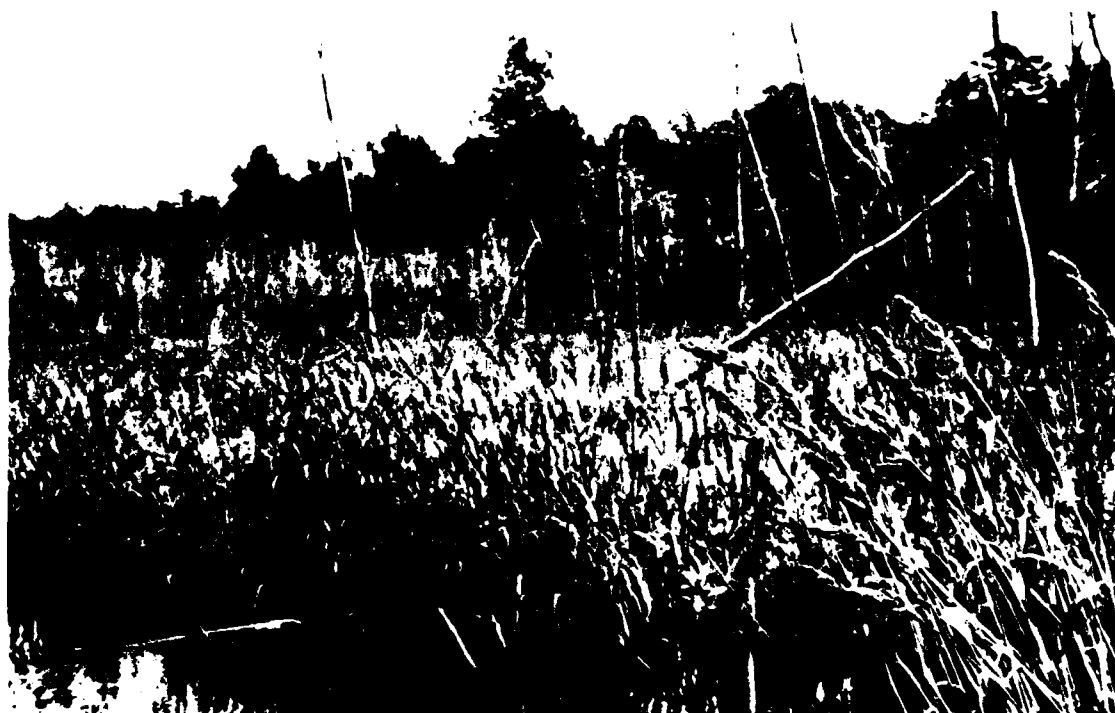
Figure 4. Japanese millet (*Echinochloa crusgalli*) growing in a partially reflooded beaver pond

Water should be kept off the area until the millet becomes established. The drain should be checked and maintained frequently until the plants average about 1 ft in height. From this stage until maturity, the millet will tolerate and grow well in water that averages $1/4$ to $1/2$ the total plant height (Fig. 4). In areas subject to armyworm (larvae of the moth Family Noctuidae) infestations, incremental flooding of the growing millet may help reduce damage by creating a movement barrier for the young caterpillars. In Wisconsin, Linde (1969) also recommended incremental flooding to provide waterfowl brood cover and to help prevent frost damage; the residual heat of the water apparently protects the millet from frost. As the millet crop approaches maturity (45 to 90 days after planting), beavers should be allowed to reflood the pond to its original depth.
